**Aggregate Extraction
and Pit Rehabilitation in Toronto
- A Historical Review**

(Revised 1992)

S.E. Yundt, BA, MA

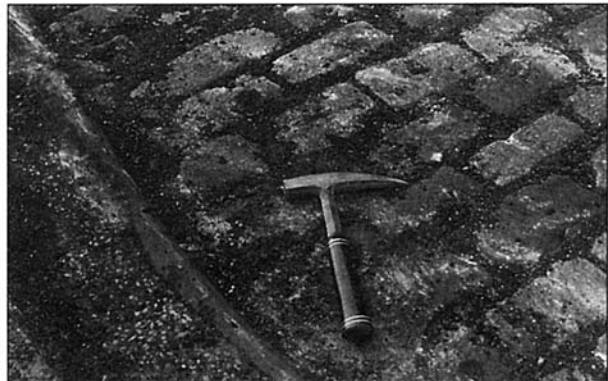
*Photograph 1
 Granite bricks were once a very popular road building material. In the reconstruction of Bloor Street in 1978, a layer of these bricks was uncovered as part of the old road base.*

In 1893, the Ontario Bureau of Mines Annual Report gave the general opinion on road building materials as follows: Granite was durable but expensive to keep in good repair (Photograph 1). Long distance hauling of granite resulted in high costs since much of the rock was brought in by boat. Asphalt was thought to provide a good smooth surface, but when wet, almost too smooth and slippery for horses' hooves. As with granite, asphalt costs were high, especially when sewers or other underground work necessitated the removal of the surface. In spite of these drawbacks, the first asphalt was laid on Bay Street south of King Street around 1888 (Ontario Bureau of Mines, 1893, p.106).

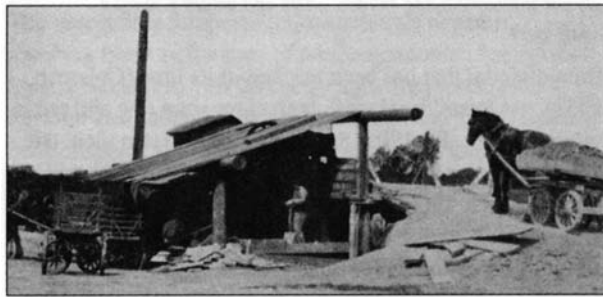
Photograph 4
Simple soft-mud plant at Chapman Brick Company, Dawes Road operating in 1930. In a five month season, the plant produced 2 million bricks.

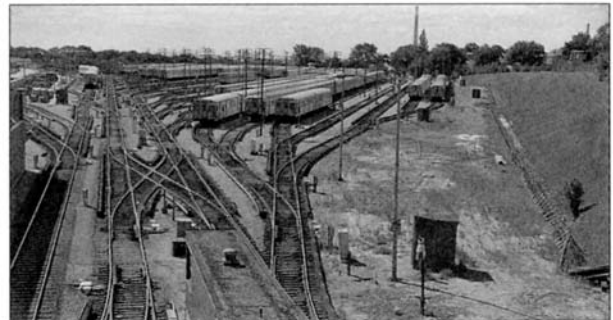
Photograph 5
Site of the Toronto Transit Commission's Greenwood subway yard. The depression offers protection to the subway cars parked and serviced here.

At this site much of the glacial till deposited by the glaciers was removed by the wave action of Lake Iroquois and a comparatively thin layer of sand was left on top. Beneath this is the interglacial clay deposit averaging a depth of 18 metres. The top layers of the peaty clay have been leached of any lime and, consequently, the brick burns to the bright red colour mentioned previously. Price's, Logan's and Wagstaff's brickyards were a few of the many yards located on Greenwood Avenue at the end of the 19th century (Baker, 1906). Their pits were located north of the Canadian National Railway tracks on the banks of a ravine about 30 metres deep. The clay was dug from the bottom of the ravine on both steep banks (Baker, 1906). These pits have long since been closed down and rehabilitated (Site 51). The ravine has been landscaped and now serves as a green space. On the west side of Greenwood Avenue is the present site of the Toronto Transit Commission's subway yards (Site 50). The shape of the former pit is clearly evident and the depression offers protection to the trains that are parked and serviced here (Photograph 5).

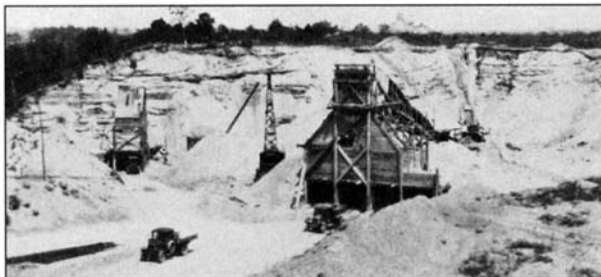
Photograph 6
Scarlett Plains sand pit, east of Lambton Golf Course is now part of a housing development. In 1932 it was a bustling and productive extraction site as motor vehicles began replacing the horse teams.

Photograph 6 illustrates the activities that went on in the Scarlett Road area in 1932 and the aerial photograph (Photograph 7) shows that even more pits were present over 20 years later.

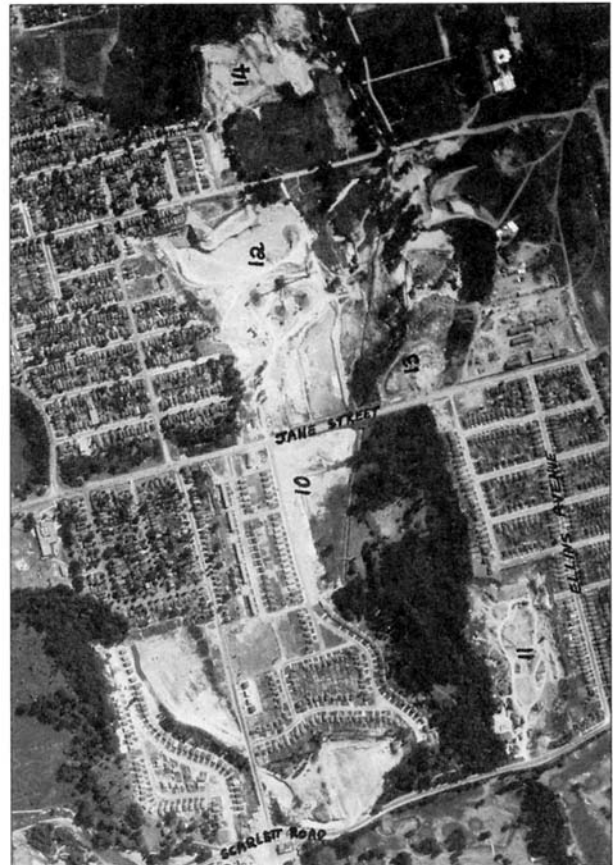
Photograph 7
In 1954, extraction activity at Jane Street - Alliance Avenue was still in full swing. Several sites which are now rehabilitated are identified on the aerial photograph.

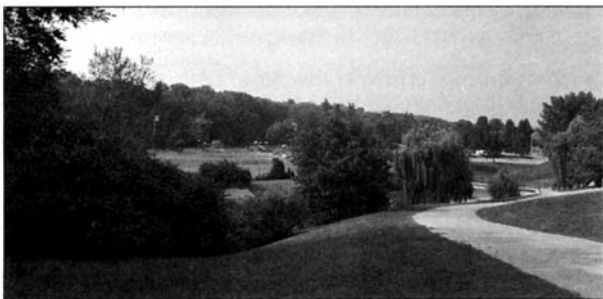
Photograph 9
 Partial view of the rehabilitation at Smythe Park. The rehabilitation of this former gravel pit includes recreational facilities such as a playground, tennis courts and a swimming pool.

At the end of this street at Weston Road is the Borough of York Stadium (Site 15) built into the edge of an old pit face. These and probably several other unrecognizable sites on the Davenport Gravel Bar have served Toronto well in providing essential construction resources (Photograph 9).

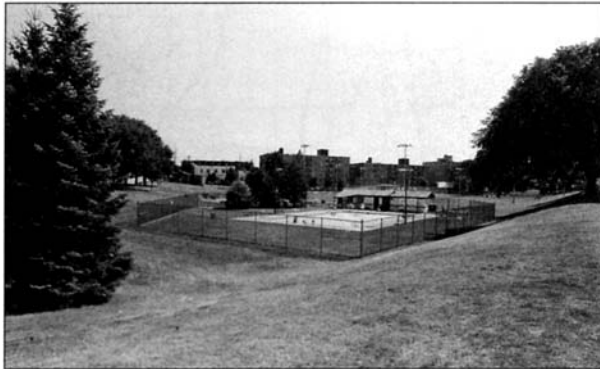
Photograph 10
Blantyre Park is one of many rehabilitated pits on the eastern gravel bar. A swimming pool, baseball diamond and playground are some of the recreational features of this park.

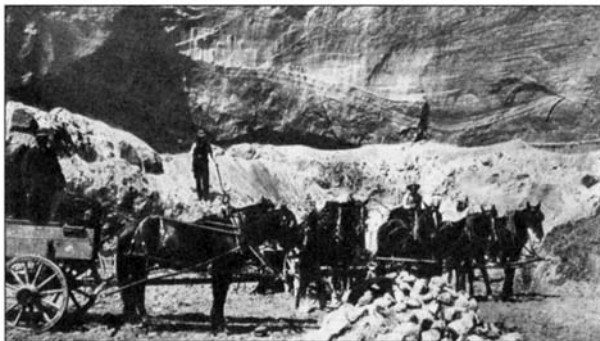
Photograph 11
Shaw Street sand pit was excavated in a 24 metre deposit of crossbedded, sandy materials. Willowvale Park now occupies this site.

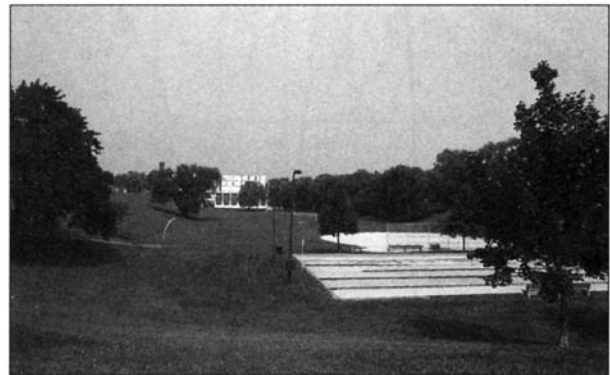
Photograph 12
Bickford Ravine with Bickford High School in the background. The shape of the pit is conducive to sports such as baseball, soccer and football, which are played here.

Today on the south side of Bloor Street at Christie Street stands the modern Bickford High School built on the floor of one of the depleted pits (Site 32). Behind the school is Bickford Ravine. The large size of the willow trees on the slope indicates the length of time since extraction took place (Photograph 12).

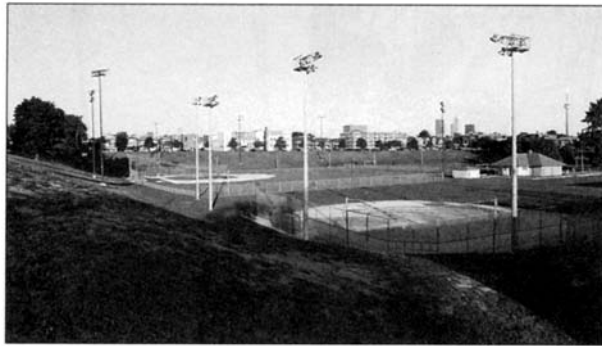
*Photograph 13
Willowvale Park, commonly known as “Christie Pits”, provides for several recreational activities in a densely urbanized area.*

Across Bloor Street to the north, another pit has been converted to recreational use (Site 33). This area has long been known as the “Christie Pits”. Willowvale Park is the area’s official name and as well as providing a swimming pool, badminton courts and floral display, it is also the home of the Toronto Maple Leaf Inter-County Baseball Team. Further to the north, along Pendrith Street is another old pit, now built over with houses (Site 34).

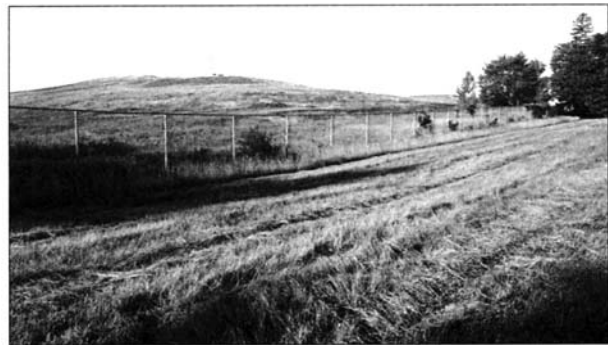
*Photograph 14
Beare landfill site in Scarborough is located on several former pit sites.*

As previously mentioned, some abandoned pits were used for sanitary landfill sites. As least two pits were filled as part of the Beare landfill site in Scarborough (Sites 80, 81; Photograph 14). Two other landfill operations were located at Morningside Drive and Highway 401 (Sites 71, 72). Landfill activities have been completed creating a large hill. The area is now managed as Military Trail Park by the Scarborough Parks Department. South of this, on property owned by the University of Toronto, is a pit partially filled in with landfill and another containing water. Although much has already been done, this entire site including the two pits and the landfill area could use further landscaping to turn it into an attractive and more enjoyable recreation area.

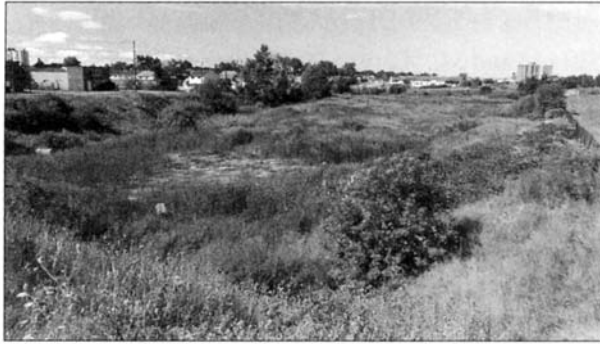
Photograph 16
Natural revegetation taking its course in an abandoned pit at
Gerrard Street and Victoria Park Avenue (Site 61).
